# ILLINOIS AND MICHIGAN CANAL NATIONAL HERITAGE CORRIDOR

**Volume II: Morris**

HABS/HAER Division  
National Park Service  
U.S. Department of the Interior

### **VOLUME II: MORRIS**

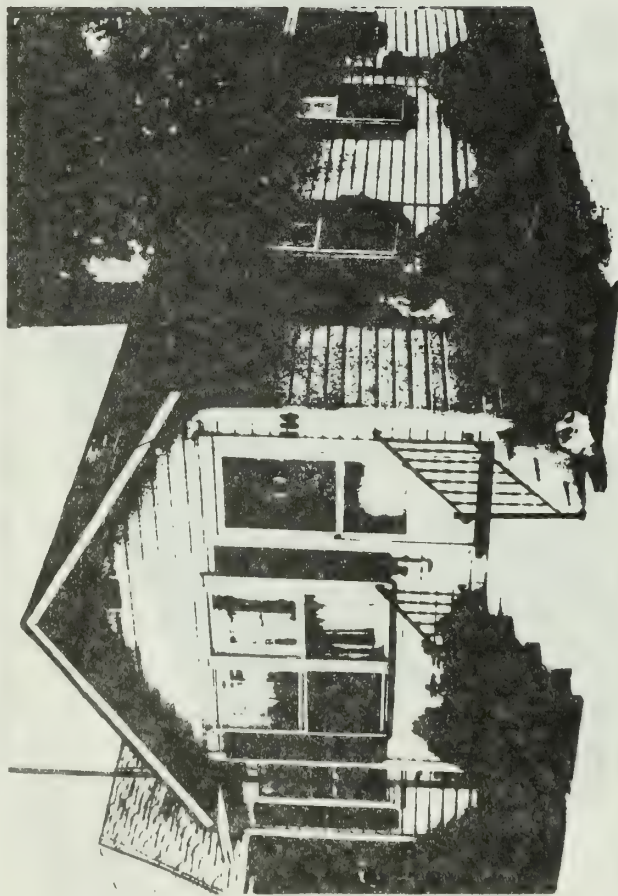
Roll 28, 25

Concrete block foundation; wood frame construction; wood weatherboard cladding, wood cornerboards. Rectangular plan with three-bay front. One story. Front gabled roof with asphalt shingles, exposed rafters, wide plain frieze board. One entrance with wood paneled door. three vertical lights. One paired double-hung six-over-one-light wood sash window and one double-hung one-over-one-light wood sash window; shutters. Concrete steps, wrought iron handrail. Main facade faces east; main ridge runs east-west.

Located within one block of the I&M Canal, structure is typical of the smaller-scale residential buildings constructed in the area.

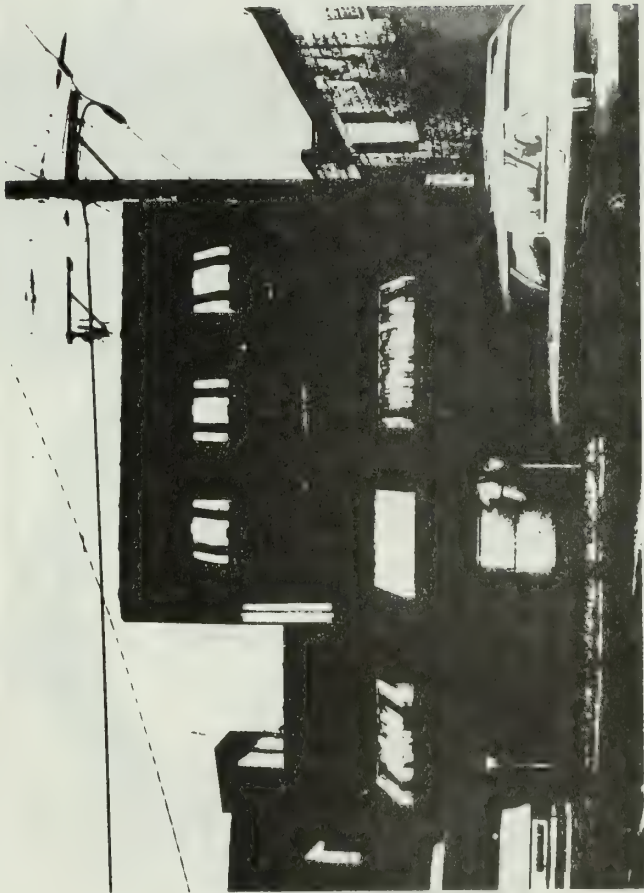
Roll 27, 26

Limestone, concrete block, and brick foundation; brick walls on south, concrete block walls on north; vertical channelled wood cladding on west and on west-end of south wall, stucco over masonry on south and north. Rectangular plan; three-bay front. Two-story original building with one story addition (ca. 1900). Flat roof; parapet wall on west, terracotta coping. Main facade has one wood-frame glass door with single light; two first-story metal horizontal rectangular windows; three second-story metal-frame one-over-one-light double-hung sash windows. Main facade faces west; located in middle of block, south of alley. Alterations include wood cladding on west, stucco on north and south; addition of north wing ca. 1900. Original two story section appears as saloon on 1889 Sanborn map; subsequent uses include carpenter shop and second-hand store. Tavern run by same family since late 1930s; remodeled in 1953.

Building is representative of small-scale commercial structures built in Morris in the latter years of the 19th century. Alterations have compromised the architectural integrity of the structure.

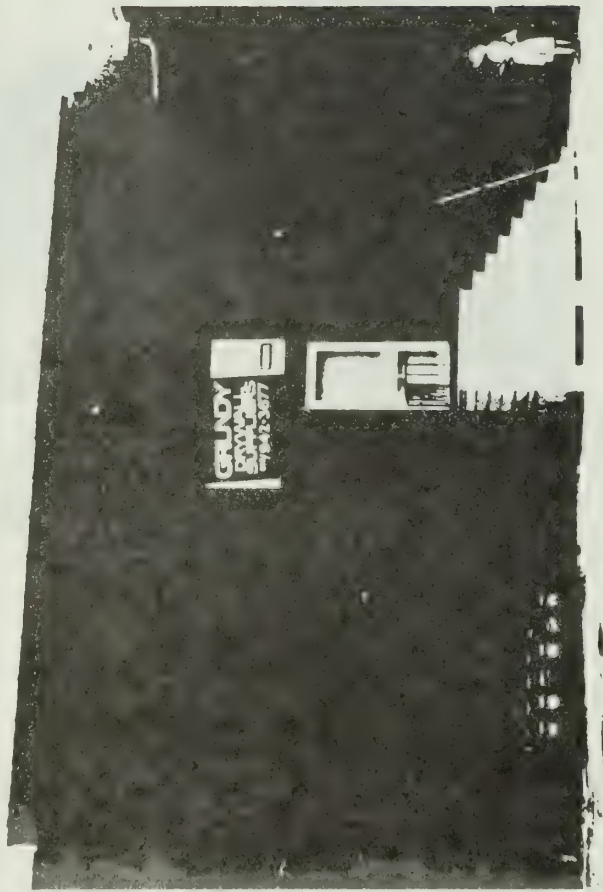
Roll 27, 28

Poured concrete foundation; concrete block construction, buttresses on west. Rectangular plan; three-bay front. Two stories. Flat roof; parapet on north and south, terracotta coping; metal gutters on west. Raised central entrance modified with replacement slab door and fixed nine-light window; two flanking openings covered with corrugated metal sheets. Main facade faces south; in middle of block of commercial structures facing street bordering the canal.

Site is important for its proximity to the canal, the courthouse and the central business district.  
Use of structure is in keeping with historical commercial/industrial activities along the canal.

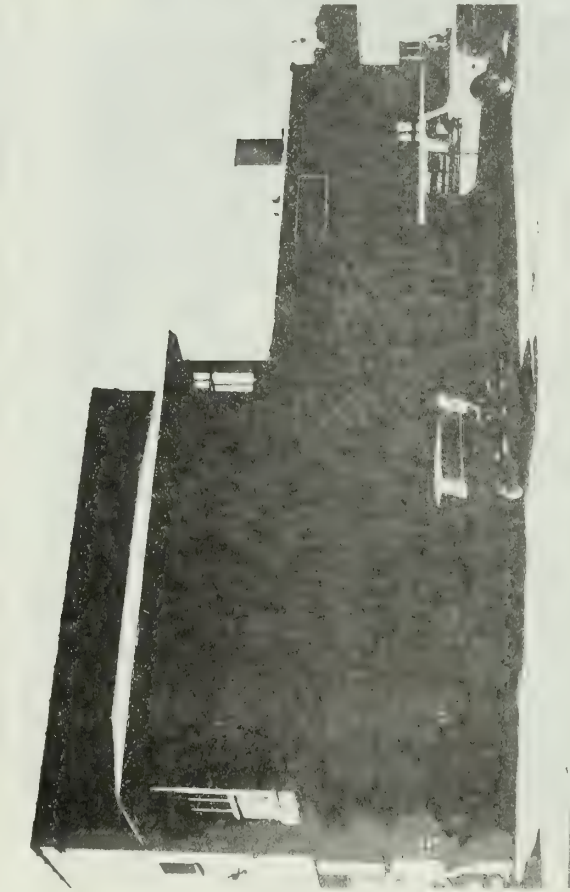
Roll 27, 12

Brick and poured concrete foundation; common bond painted brick walls; rug brick on north facade with simulated-quin returns on east and west facades. Rectangular plan with nine-bay front. Two stories on east, one story on west. Flat roof with terracotta coping; parapet wall on north. Four chimneys with corbeled bases and concrete coping on east; single chimney with concrete coping on west wall of two-story section. Storefronts on front facade: one-story section has overhead garage door flanked by two fixed metal fifteen-light windows (rows three and four of lights are awning windows) with concrete sills, slab door with single light and four-light transom; three-cross panel door with square one-light transom; two fixed metal fifteen-light windows with awning windows flanking display window with three-part transom, rowlock sill; vertical-two-panel door with nine-light glass and four-light transom. Paneled brick cornice with two horizontal rows of stretchers flanking one row of soldiers; enclosed overhanging second story wooden porch with low-pitched hipped roof with metal flashing, closed rail, Prairie windows. Main facade faces north; south (rear) facade faces canal; across from rear of courthouse, one block from central business district. Recent changes in fenestration on sides and rear of structure.

Proximity of site to the Canal, courthouse and central business district make this an important location for commercial activity along the Canal. Sanborn maps show this as the site of a livery until 1927 when the current building was constructed to house a blacksmith and auto repair shop. Similar commercial uses continue today. Building maintains scale and setback of other similar structures along the Canal.

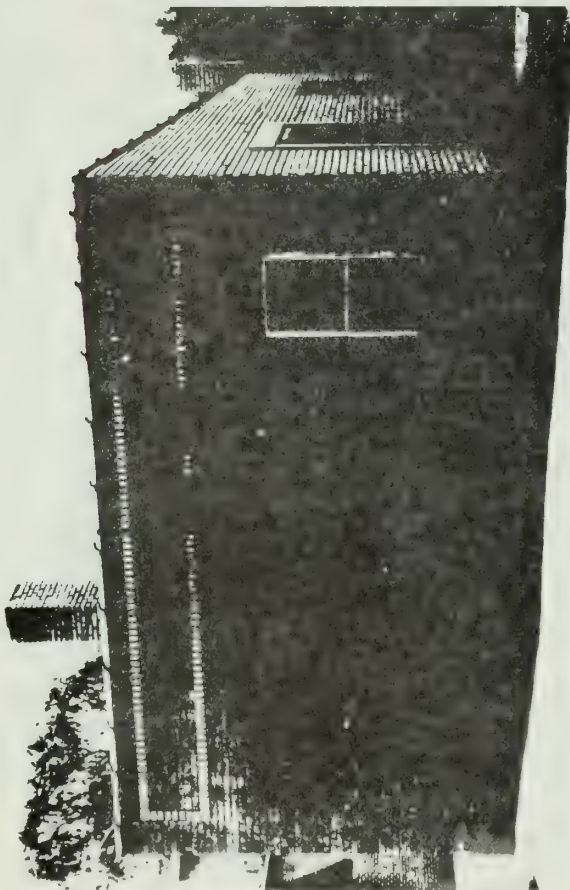
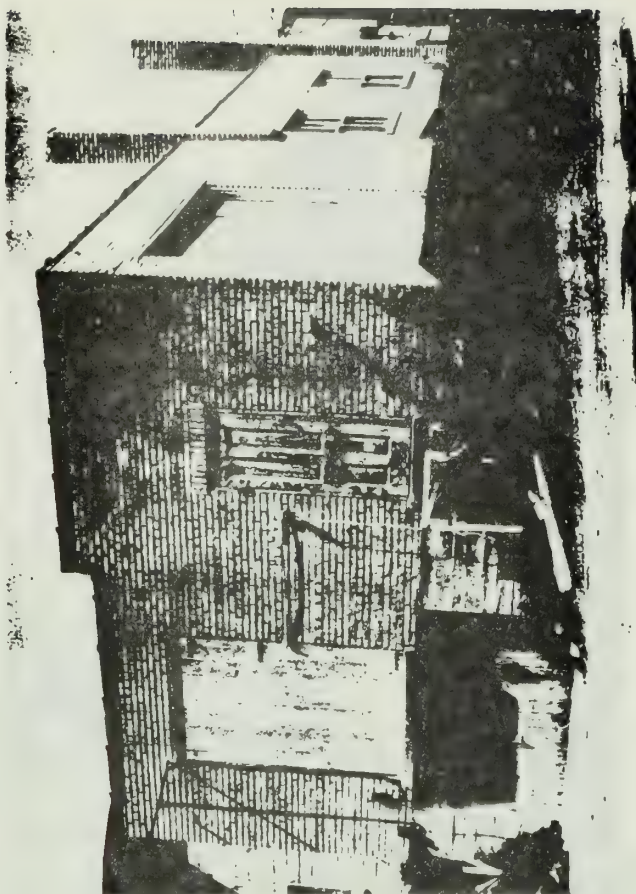
Roll 27-10

Foundation of brick (front) and poured concrete (rear): common bond painted brick walls, rug brick on front, smooth-faced brick on sides and rear. Rectangular plan; two-bay front facade. One story. Flat roof sloping to rear, terracotta coping. Two chimneys on east wall, south-end chimney with corbelled base; one chimney on west wall with corbelled base.

Proximity of site to Canal and to central business district make this an important location for commercial activity along the Canal. One of group of three buildings constructed by Frank Rudow in late 1920's - early 1930's, compatible in materials, scale and detail with earlier commercial buildings in the area. Sanborn maps show this as the site of a feed yard until ca. 1920.

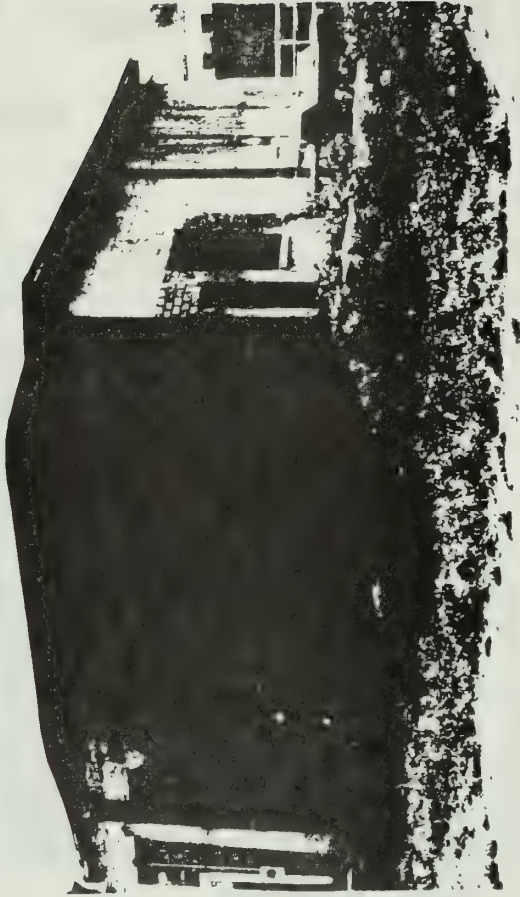
Roll 27, 8

Concrete block foundation; wood frame construction; concrete block walls on east; stucco and vertical channeled wood on north; concrete and tile block on south and west. Rectangular plan; four-bay front. One story. Convex roof with low parapet and overhanging eaves; exposed rafters on south; terracotta coping, metal flashing, wood fascia board. One entrance, replacement garage door. Two windows: one metal hopper window with thirty-two lights; one Chicago-type window, wood frame. Poured concrete buttresses on west. Ridge line runs north-south; main facade faces north. Constructed by Frank Rudow.

Alterations: building was originally one-story. Original door and windows have been replaced and/or bricked-in. Site of early Morris feedyards (H.C. Henderson, 1889; O.F. Penfield, 1894; H. Holliday, 1907).

Located adjacent to the Illinois and Michigan Canal, the existing structure and its site serve to reinforce the historical importance of the Canal as a corridor of industrial activity.

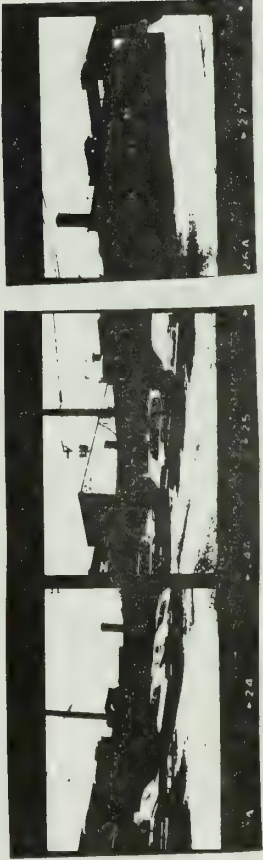
Roll 27

Located near the I&M Canal, the existing structures serve to reinforce the historical importance of the canal and to clarify its relationship with the early industrial and commercial development in Morris. Modern alterations have compromised the architectural integrity of the buildings.

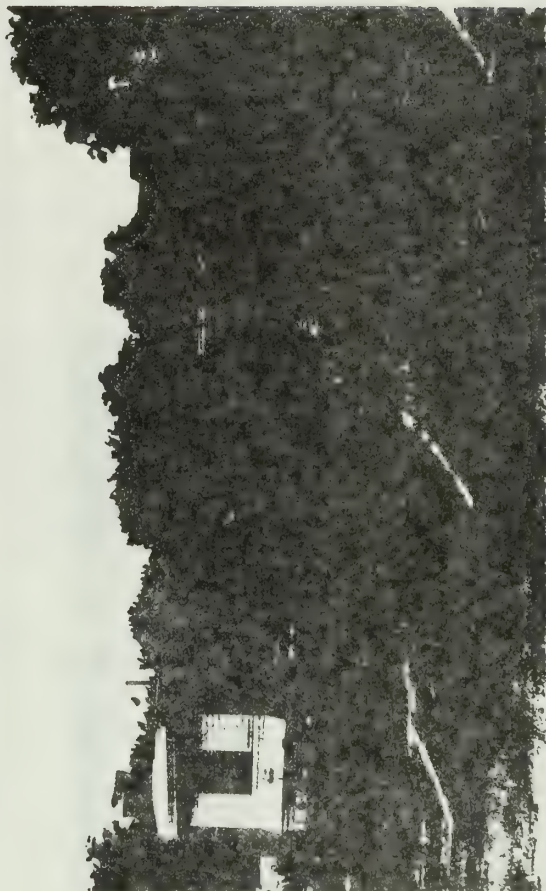
Roll 28, 27

Visual intrusion. Located in industrial area adjacent to I&M Canal.

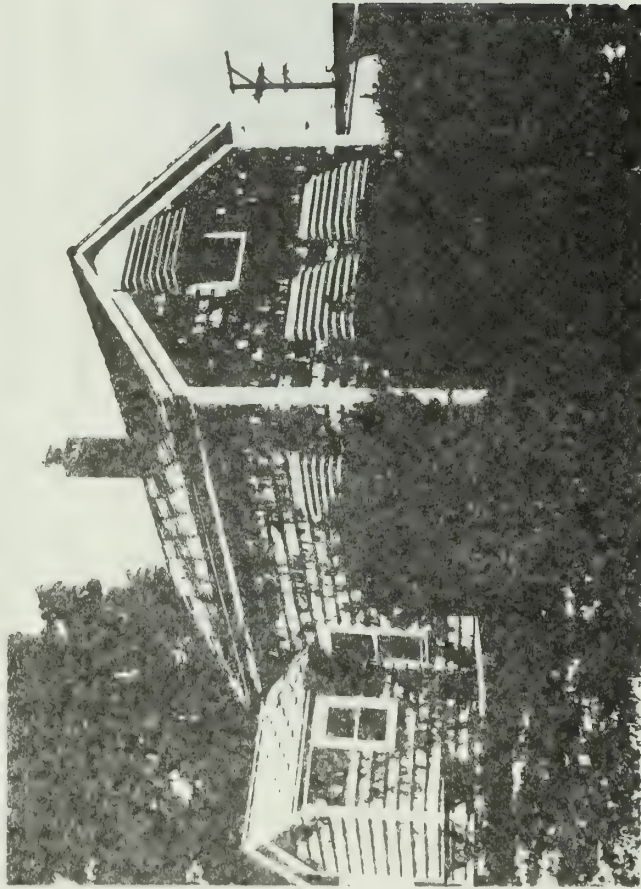
Roll 28, 28

Concrete block foundation; wood frame construction; staggered shingle cladding, wood cornerboards. Rectangular plan. One and one-half stories. Intersecting gable roof with diamond pattern slate shingles, ridge roll, boxed cornice, plain wide frieze board, half-round metal gutters. One entrance porch. Double-hung one-over-one-light sash windows with metal louvered awnings. Main facade face of porch, main side runs north-south. Alterations include metal awnings. One of early blacksmith operation (late 19th-early 20th century).

Building is representative of the later small residential buildings constructed in Morris in the 1920s-1930s. Structure is one of the few residential buildings located in this predominately industrial areas along the canal.

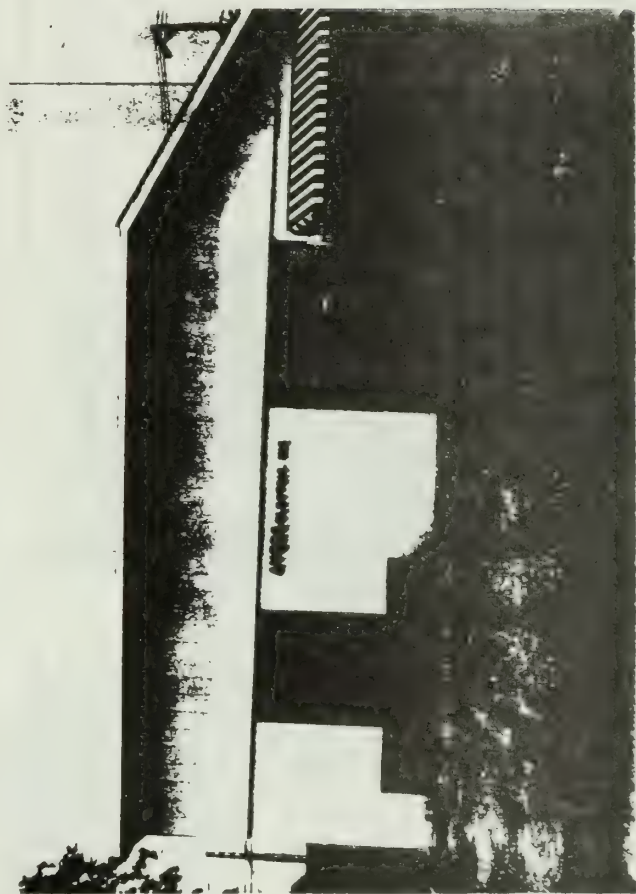
Roll 28, 29

Recent construction near canal; building is similar in scale to earlier industrial development along the I&M Canal. No historic importance.

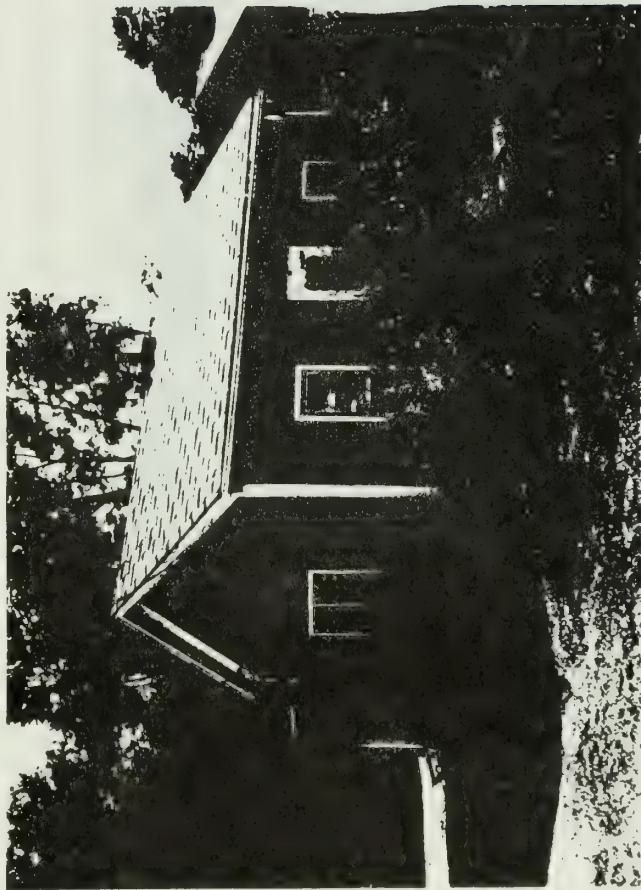
Roll 37, 28

Poured concrete foundation; wood frame construction; wood shingle cladding. L-shaped plan; three-bay front. One story. Cross-gable roof with main ridge parallel to street; interlocking asphalt shingles on main roof, roll roofing on porch roof. Low smoke-stack on main ridge. Main facade has center replacement wood slab door flanked by one-over-one-light double-hung metal sash windows. Southeast open entry porch. Main facade faces north; main ridge runs east-west; backs onto canal in block of small-scale residential structures.

Late 19th century cottage next to canal; mirror image of 305 W. Illinois when constructed (305 has been altered). Example of small-scale housing built along canal.

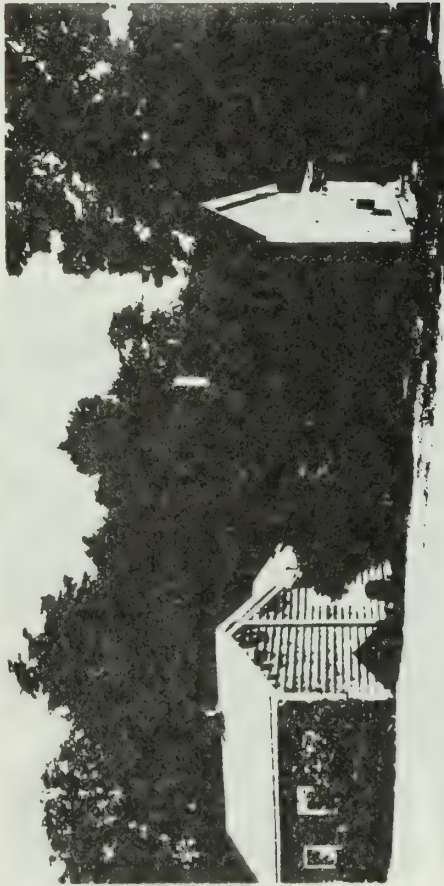
Roll 37, 29

Limestone foundation; wood frame construction; asbestos shingle cladding. L-shaped plan with enclosed porch; three-bay front. One story. Side-gable roof with asphalt shingles; hipped roof on rear ell, roll roofing. One brick chimney on ridge. One-light three-cross-panel center door flanked by one-over-one-light wood frame double-hung sash windows. Main facade faces north; main ridge runs east-west; building backs onto canal in block of small-scale residential structures. Alterations include enclosed porch on southwest and modification of rear-ell gable-roof to hipped.

Late 19th century cottage next to canal. Mirror image of 301 W. Illinois when constructed. Example of small-scale housing built along the canal.

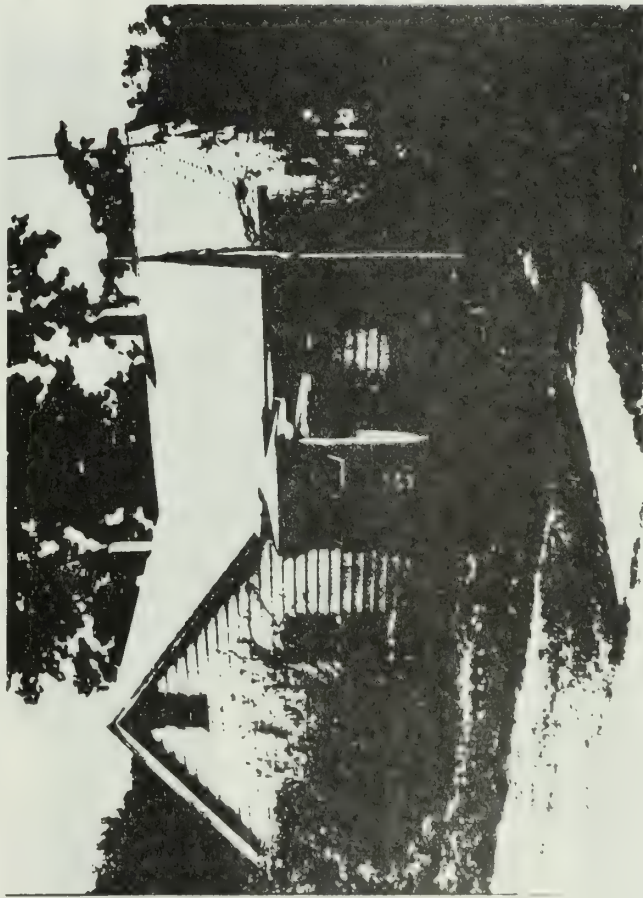
## Roll 37, 30

Site is significant for its proximity to the canal. Located in residential block in an area of primarily commercial buildings and warehouses.

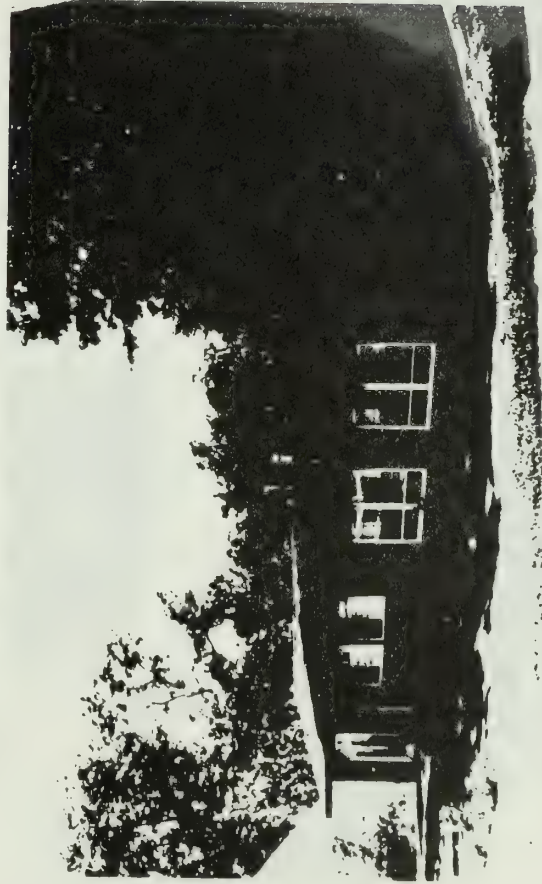
Roll 37, 31

Site is significant for its proximity to the canal. Building maintains scale and materials of surrounding residential structures.

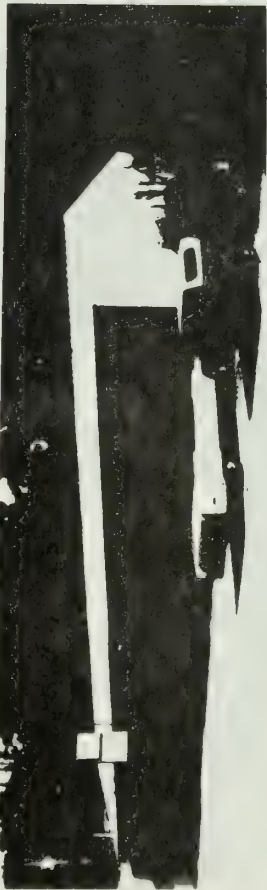
Roll 37, 34

Proximity of site to canal; compatible with historical land use along canal (commercial/industrial). Late 19th century site of G.F. Brown grain elevator. Current metal buildings not compatible in materials with surrounding historic commercial/industrial structures.

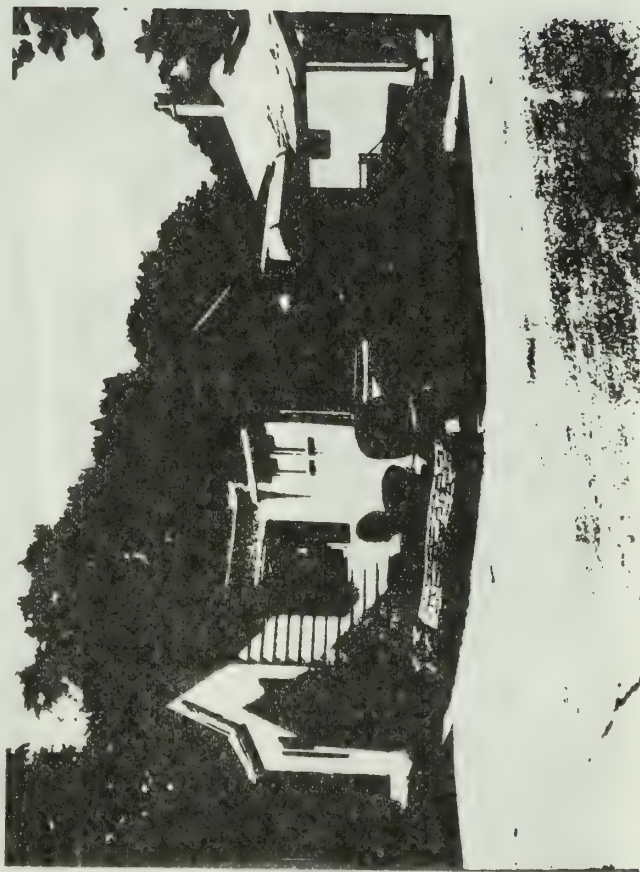
Roll 37, 37

Site is important for its proximity to the canal. Alterations and additions have compromised the architectural integrity of the structure.

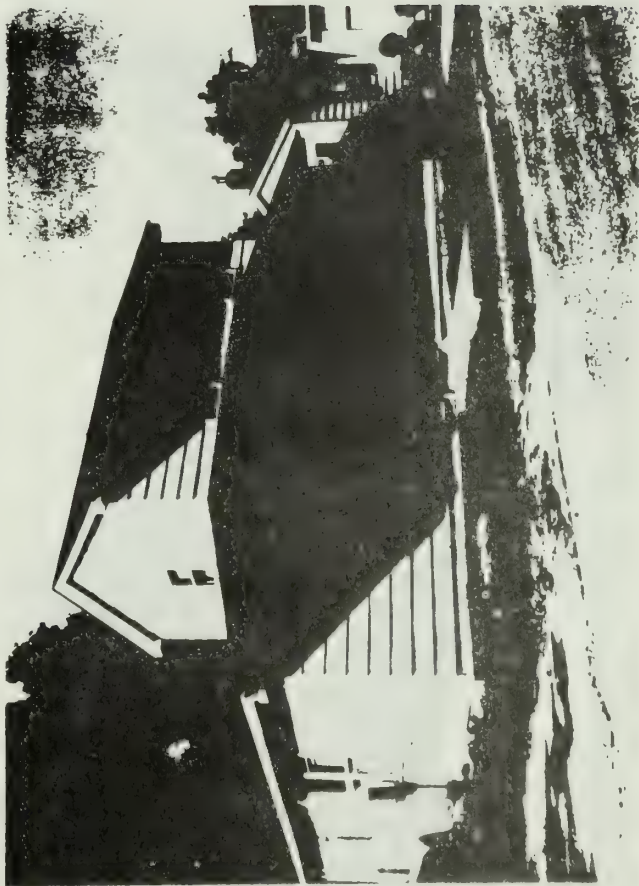
Roll 37, 36

Site is important for its proximity to the canal. Alterations and additions have compromised the historic integrity of the structure.

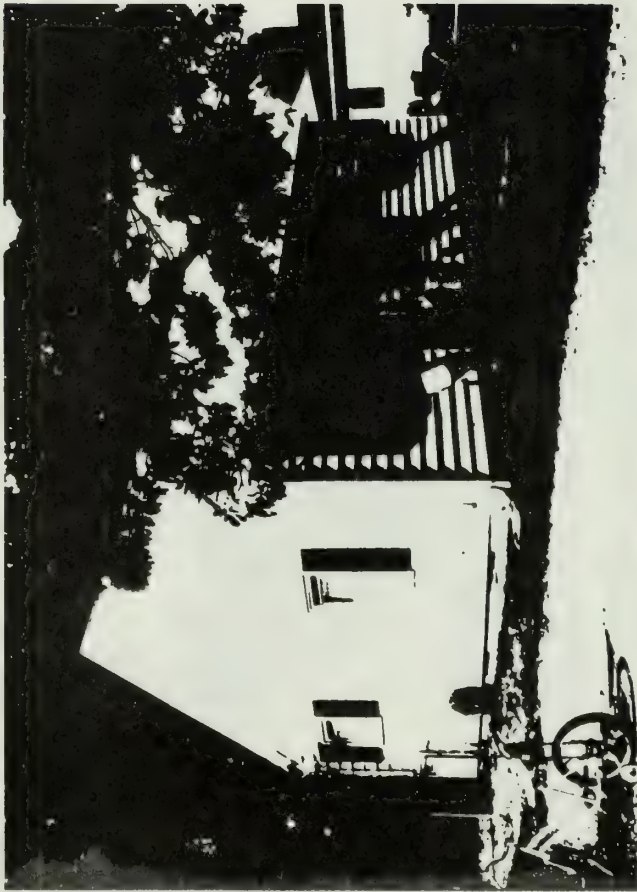
Roll 37, 35

Stone and concrete block foundation; wood frame construction; aluminum siding. Two-story original section surrounded on three sides by one-story addition. Side-gable roof on two-story section; hipped roof on one-story section; asphalt shingles. One metal storm/screen door on main facade. One-over-one-light double-hung sash windows. Main facade faces south; main ridge runs east-west; located in residential block facing commercial structures that back onto canal. Alterations include enclosed one-story section on three sides of structure; replacement doors and windows; replacement siding.

14. CONDITION	<input type="checkbox"/> EXCELLENT	<input checked="" type="checkbox"/> GOOD	<input type="checkbox"/> FAIR	<input type="checkbox"/> DETERIORATED	<input type="checkbox"/> RUINS	15. DANGER OF DEMOLITION? (SPECIFY THREAT)	<input type="checkbox"/> YES	<input type="checkbox"/> NO	<input checked="" type="checkbox"/> UNKNOWN
16. SIGNIFICANCE

Site is important for its proximity to the canal; located in block of residential structures across from commercial buildings that back onto canal. Although later, the structure is compatible in style and scale with other residential structures in the area.

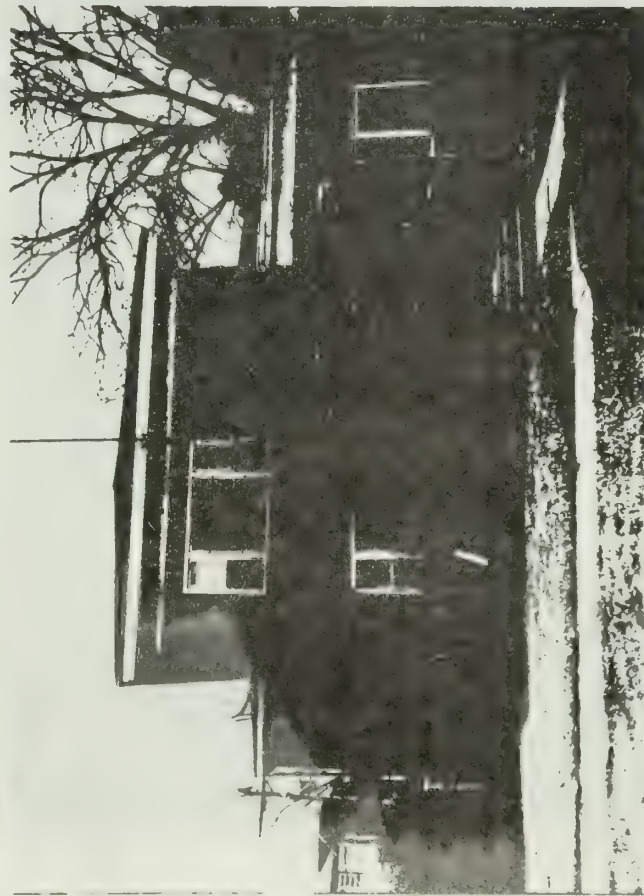
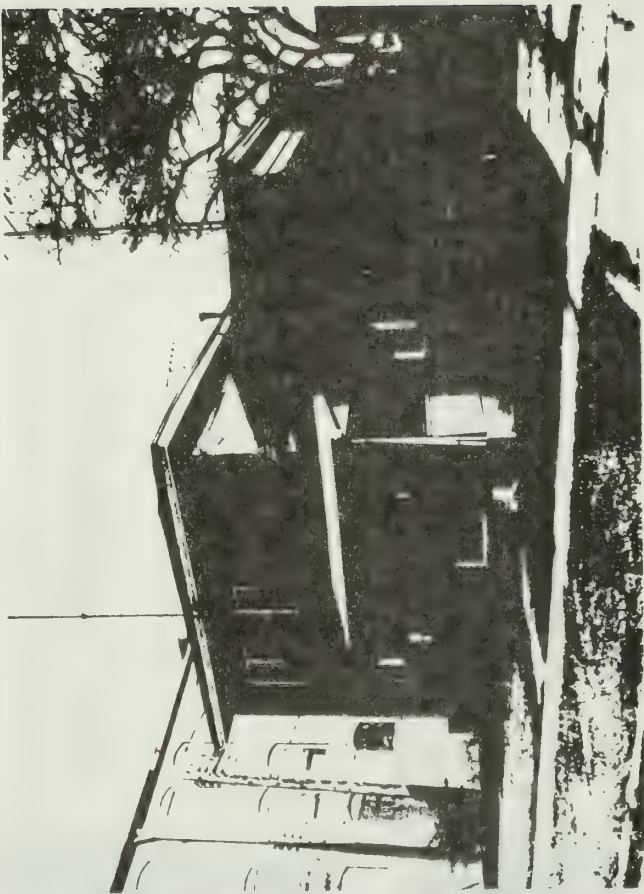
Roll 29, 36

Limestone and concrete foundation; wood frame construction covered with asphalt siding. Irregular plan; five-bay front. Two two-story sections on east; two one-story sections on west. Low pitched hipped roof; asphalt shingles; overhanging eaves, boxed cornice. Three center three-cross-panel doors with single upper lights; three Chicago-type windows, two flanking doors on first story and one in second-story. Open entry porch, corrugated metal shed roof, closed rail, narrow wood posts; two open entry porches with hipped-roof hoods on east, one on south. Main facade faces north; on edge of central business district. Appears to have been built in four stages; altered fenestration and cladding.

14	CONDITION	<input type="checkbox"/> EXCELLENT	<input type="checkbox"/> GOOD	<input checked="" type="checkbox"/> FAIR	<input type="checkbox"/> DETERIORATED	<input type="checkbox"/> RUINS	15	DANGER OF DEMOLITION? (SPECIFY THREAT)	<input type="checkbox"/> YES	<input type="checkbox"/> NO	<input checked="" type="checkbox"/> UNKNOWN
----	-----------	------------------------------------	-------------------------------	--	---------------------------------------	--------------------------------	----	---	------------------------------	-----------------------------	---

Representative of mid-late 19th Century residential structure; although greatly altered. Built in block half way between railroad and canal behind commercial structures on Liberty Street.

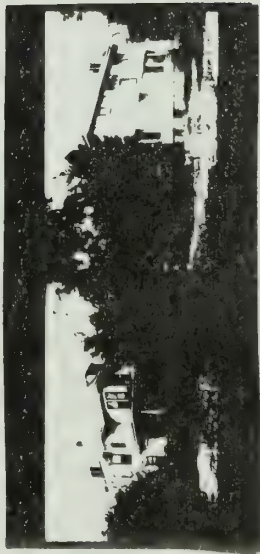
Roll 42

This eclectic Victorian house contains typical treatments of windows, porches, roofs and doors. Covering of building with metal siding has lessened the significance of the structure. Some details do remain.

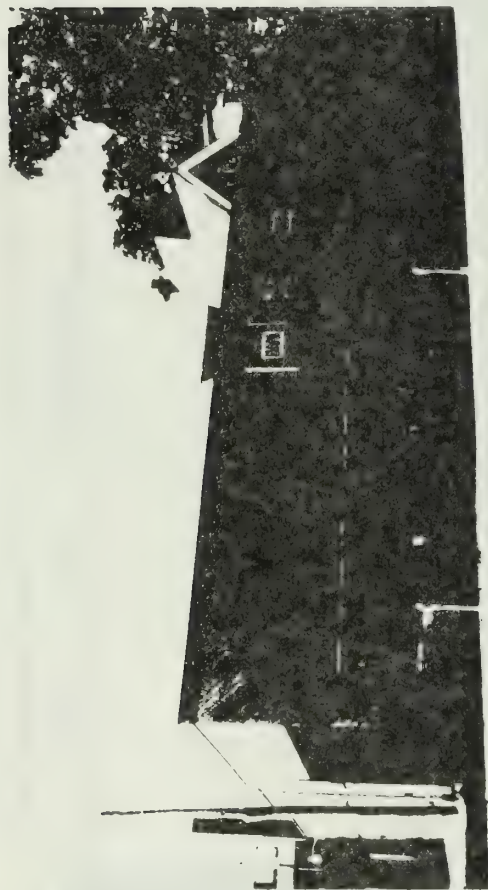
# Roll 29, 20

Located within central business district, though not on major commercial street. Recent remodeling of facade is intrusion among other brick sides structures.

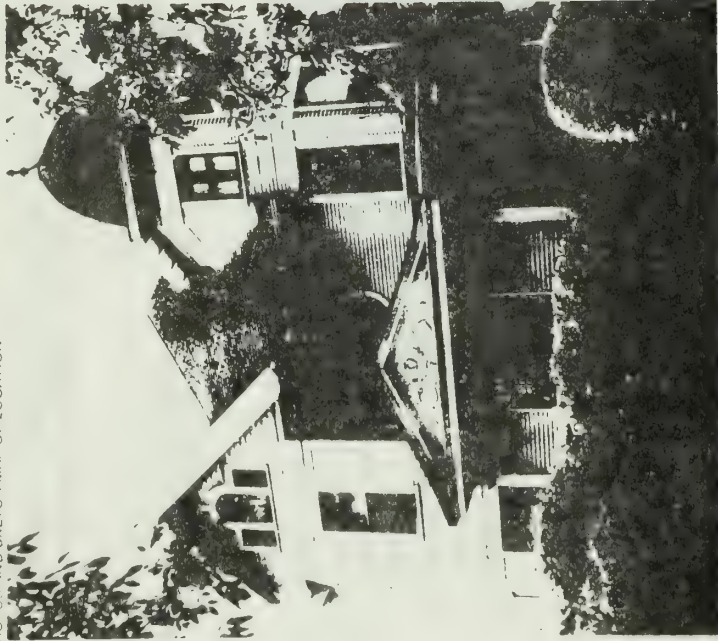
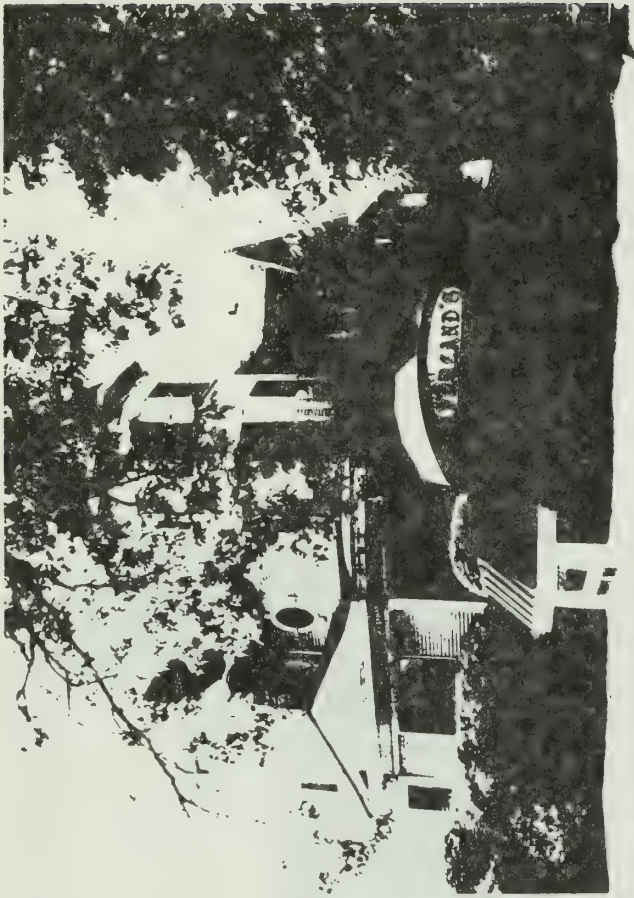
Roll 29, 22

wood frame construction; wood clapboard siding with square butt shingles in gable of canted bay. Irregular plan; three-bay front. Two-and-one-half stories. Cross-gable-on-hip roof, asphalt shingles; three-story polygonal turret with polygonal roof with finial, brackets under eaves. Interior chimney on southwest side of hipped roof. Asymmetrical fenestration; canted entrance on northwest corner with double paneled oak doors with single vertical lights; three-part casement windows with fifteen lights each, added when porch was enclosed; one-over-one light double hung sash windows in turret and on two story bays; oval leaded glass on second story main facade; Palladian windows with leaded glass sidelights and projecting wooden keystone-form on main facade and west facade gable ends. Northwest corner veranda with tuscan columns, open wrought iron replacement railing, original wooden newel post; east end of veranda, now enclosed, pediment with rinceau motif and corner posts with molded caps; wood belt course between first and second stories. Queen Anne.

Excellent example of turn-of-the-century residential architecture built by influential Morris resident: important corner site contiguous to central business district and important visual element at edge of western residential area.

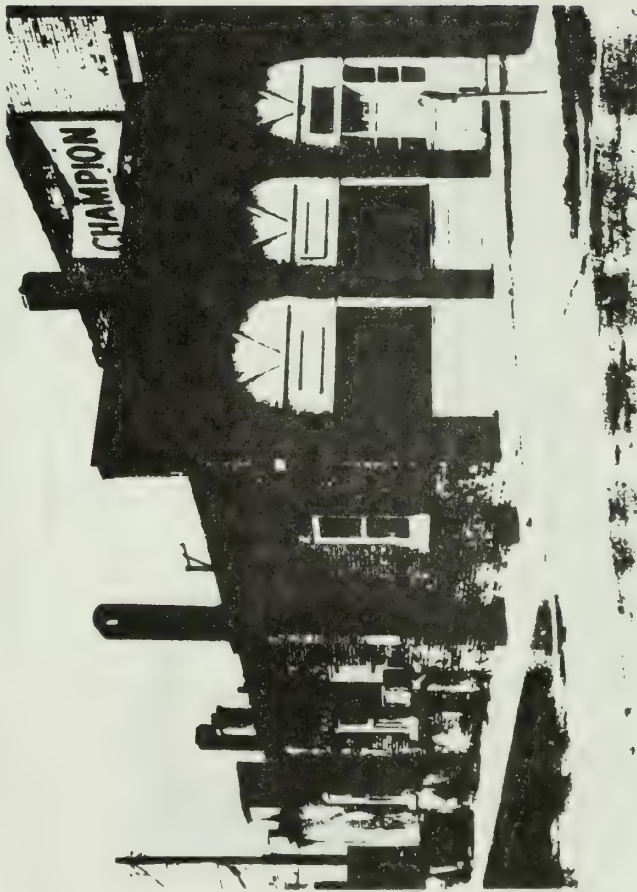
Roll 28, 4

Located on a secondary commercial street, this one-story structure illustrates the variety of commercial activity generated by the canal and the railroad in the 1870s. The scale of the surviving structure is somewhat smaller than surrounding buildings. The architectural integrity of the primary elevation appears substantially intact.

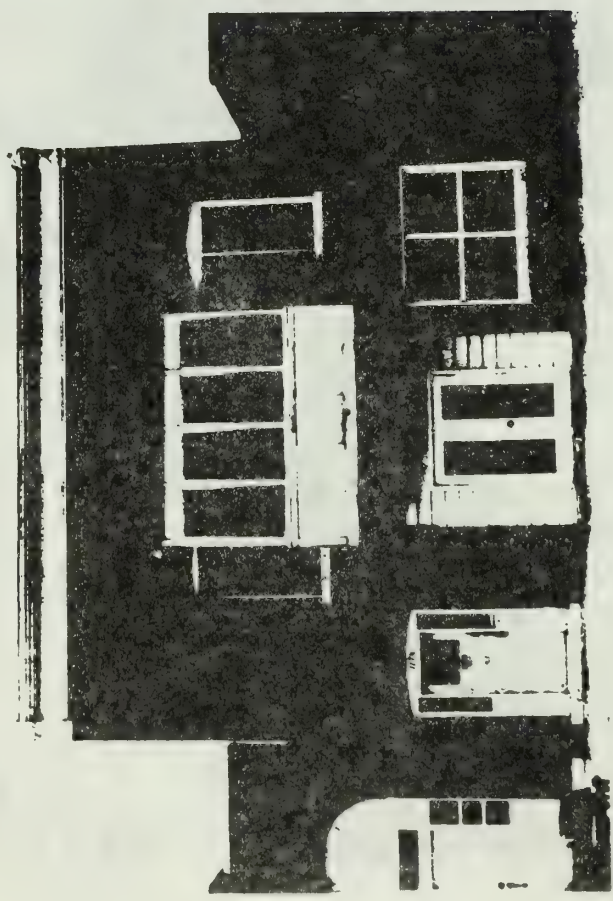
Roll 28, 5

Similar in scale to many of the area's commercial structures, the building illustrates the northerly progression of commercial activity along Liberty St. and its secondary cross streets from the canal to the railroad. Subsequent alterations and additions have compromised the architectural integrity of the structure.

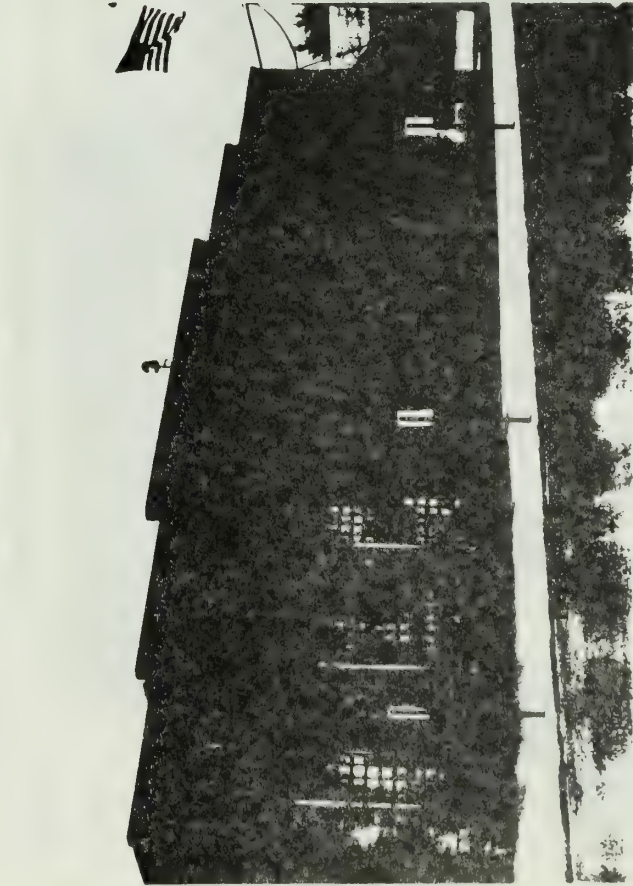
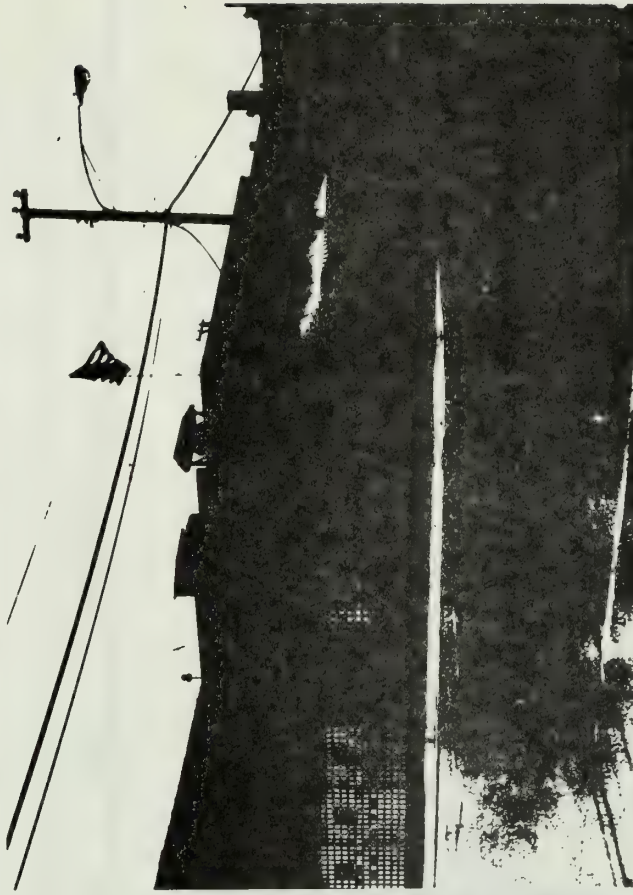
Roll 28, 6

14 CONDITION	<input checked="" type="checkbox"/> EXCELLENT	<input type="checkbox"/> GOOD	<input type="checkbox"/> FAIR	<input type="checkbox"/> DETERIORATED	<input type="checkbox"/> RUINS	15 DANGER OF DEMOLITION? (SPECIFY THREAT)	<input type="checkbox"/> YES	<input type="checkbox"/> NO	<input checked="" type="checkbox"/> UNKNOWN
16 SIGNIFICANCE

Located in historic downtown commercial area. Compatible in scale and detail with surrounding commercial structures. Neon provides an interesting decorative element in the commercial streetscape.

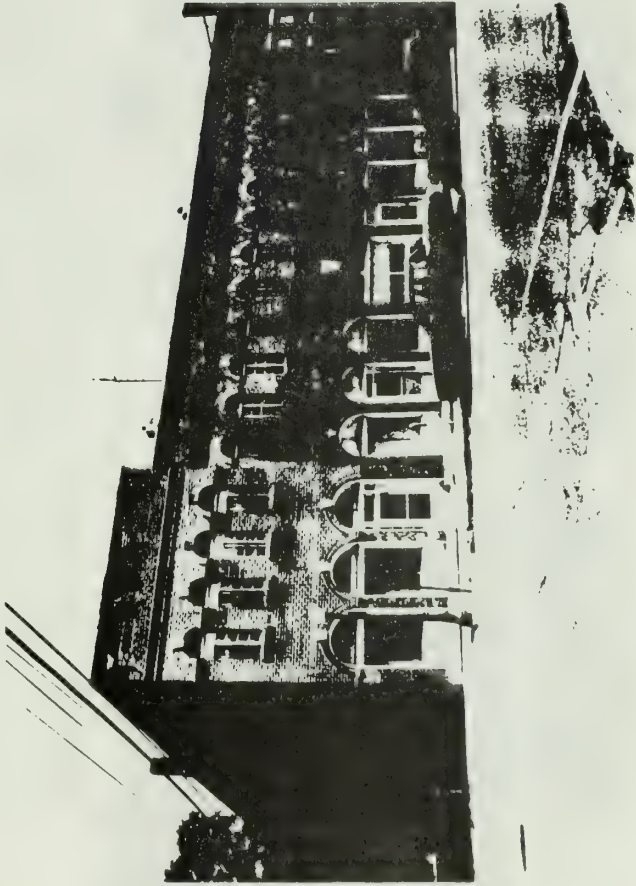
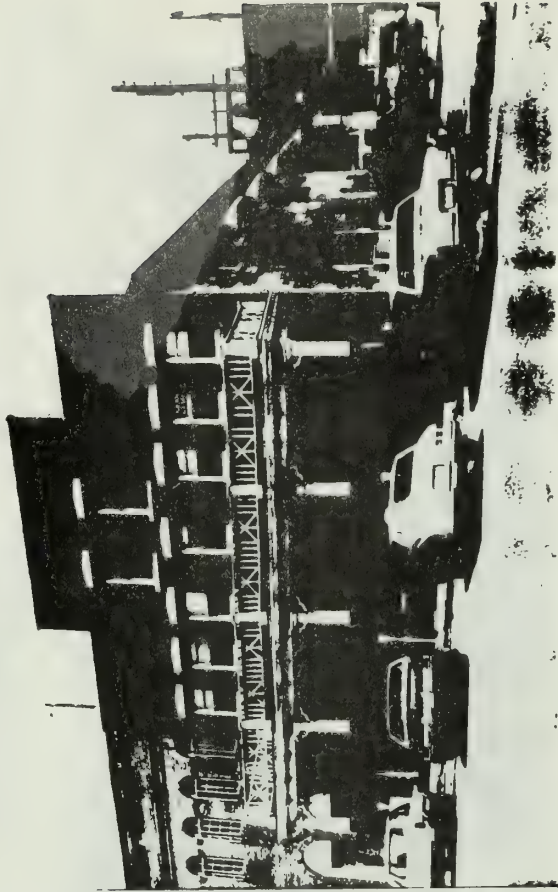
(Description continued) for apartments ca.1940s. Built by Phil. Lehr and opened in late 1867 (east section); enlarged to Wauponsee St. by C.O. Wagner in 1877. Operated by Wagner family until 1910.

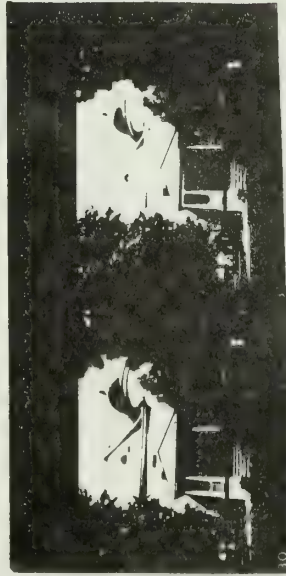
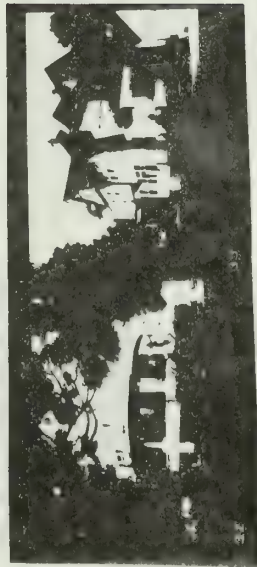
Roll 39

14 CONDITION ☐ EXCELLENT ☒ GOOD ☐ FAIR ☐ DETERIORATED ☐ RUINS

Before re-siding, house was one of finest example of early twentieth-century residential architecture in Morris. Built as an in-town residence for wealthy farmers, Johua and Oscar Collins, the house is noted for its combination of Queen Anne massing and Colonial Revival symmetry and detail. Interior woodwork, handpainted mural frieze and stained, leaded and beveled glass are especially noteworthy. House remained in the same family until 1980s. Current owners have original plans and historic photographs. Use of vinyl siding has compromised the architectural integrity of the structure..

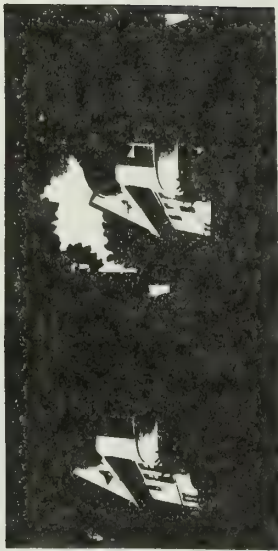
Roll 39

Example of transition from Queen Anne to Shingle style influenced house. Later Prairie-style porch addition on front facade. House was the late-19th century residence of Dr. Austin E. Palmer, a prominent Morris physician who was born in New York State in 1846 and came to Morris in 1876. He served as mayor of Morris for four years, during which time the Morris waterworks were constructed. Alterations and additions have compromised the architectural integrity of the structure.

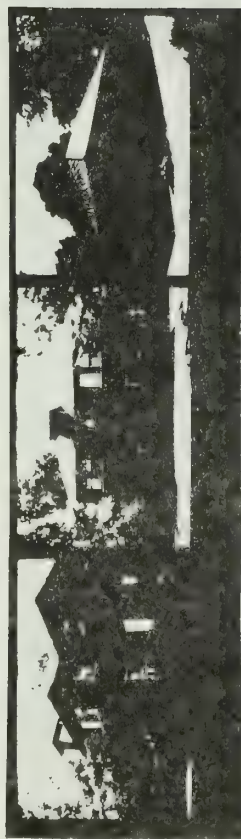
## Roll 39

Large Prairie style house similar to 320 W. Main located across the street. Built by the Gebhard family, founders of the Gebhard brewery, a major 19th and early 20th century Morris industry; now the residence of George Baum, prominent Morris merchant.

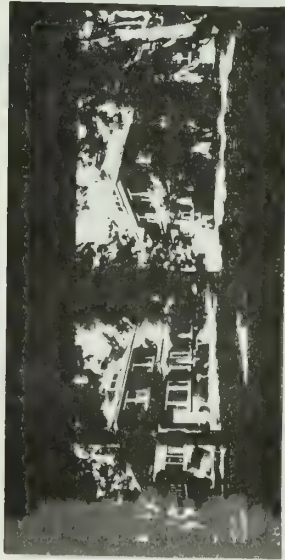
Roll 39

Large Prairie style influenced residential structure similar in design, scale and materials to 319 W. Main, located across the street. Example of architecture in Morris during the early years of the 20th century. Brick carriage house may date from the 1850s when it would have been part of the residence of G.W. Lane, an early Morris settler who operated a lumber business, a grain elevator and later served as city clerk and town assessor. This house was built for the Gebhard family, founders of the Gebhard Brewery, a major Morris industry in the 19th and early 20th century.

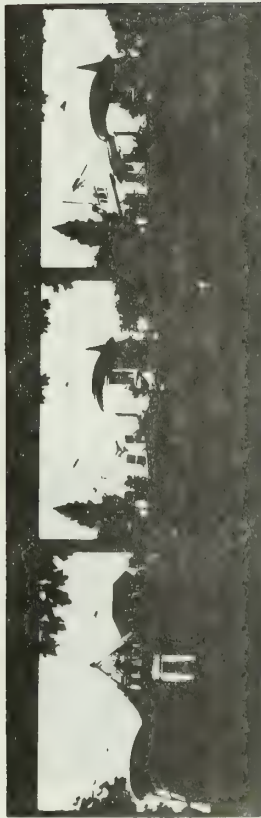
Roll 39

Large Queen Anne house originally built for the Gebhard family, founders of the Gebhard Brewery, a major Morris industry in the 19th and early 20th century. Addition of aluminum siding has compromised the historic architectural integrity of the structure, although much of the original decoration remains. Important corner location in the west residential area. With the earlier 604 W. Washington St. and the later 319 and 320 W. Main St., comprise the major residential structures built by the Gebhard family in Morris.

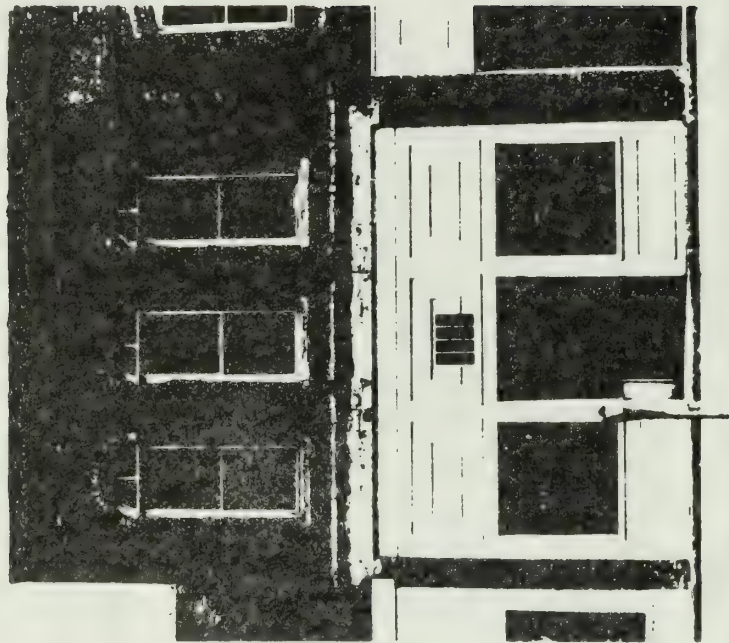
Roll 28, 16

Located in the heart of the downtown business district, the building is typical of the commercial development that occurred in Morris in the 1870s. Building retains substantial amount of integrity.

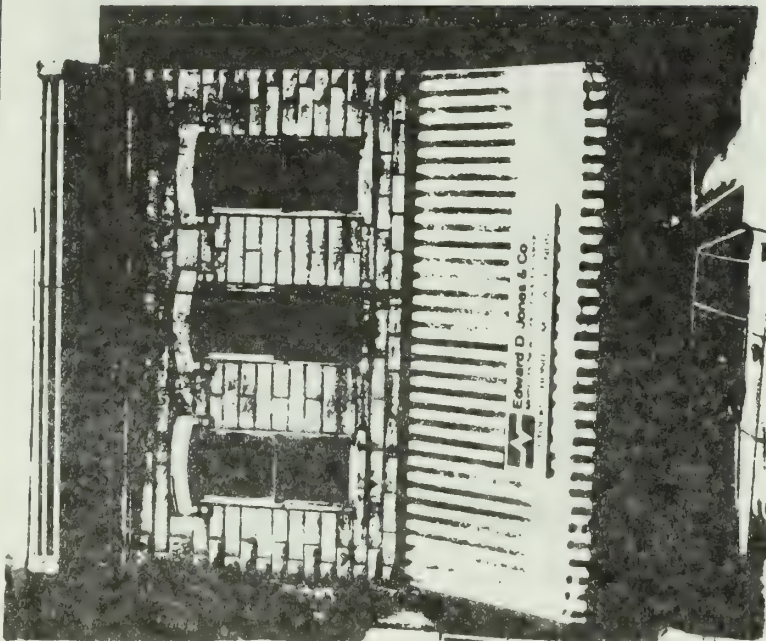
Roll 27, 19

One of four stone structures in the Morris central business district, the building is a fine example of 19th century commercial architecture in this canal community. The architectural integrity of the structure remains virtually intact.
